# Report on Fractured Bead in Tire

Kenneth C. Russell

Department of Materials Science and Engineering

June 5, 1975

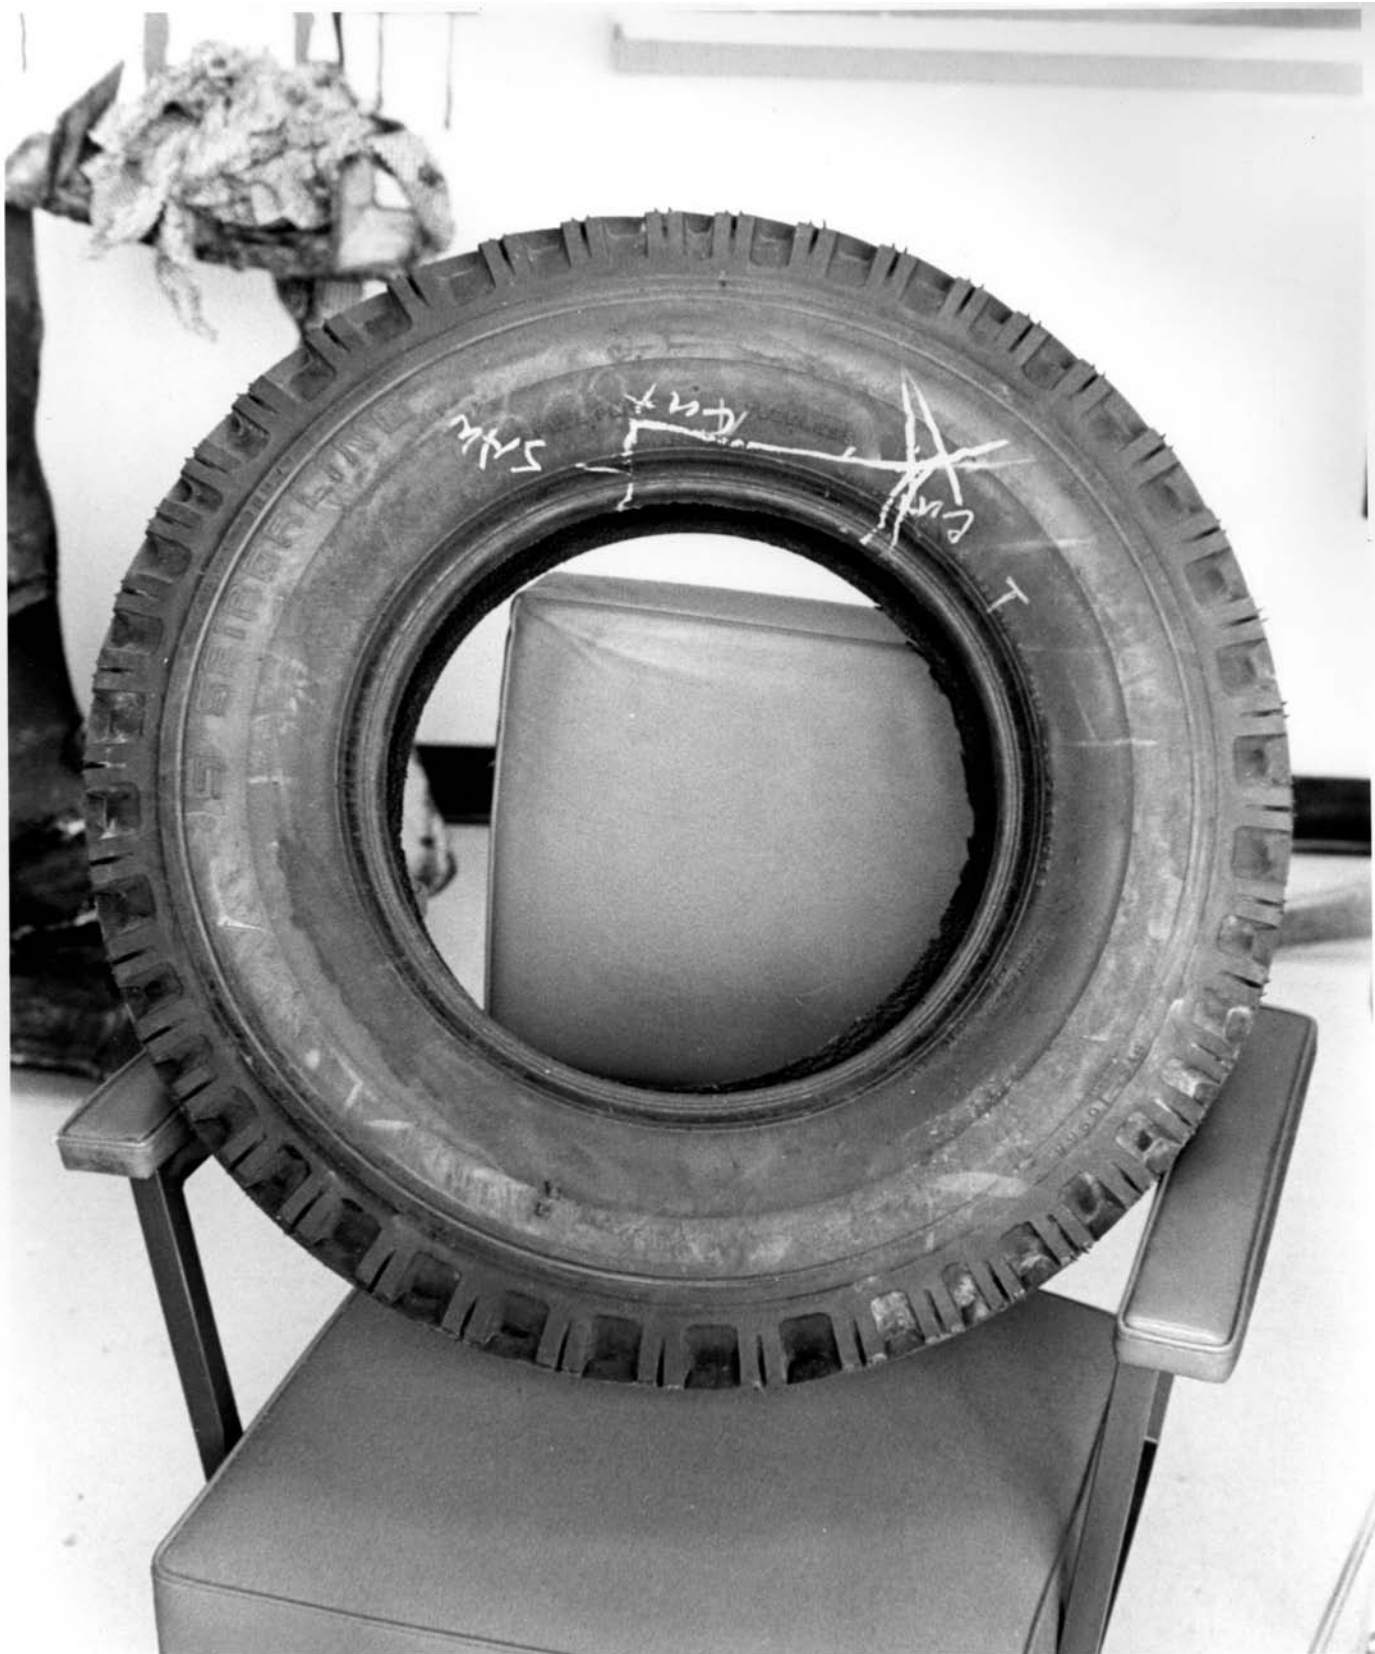
On March 11, 1975 I received the tire shown in Fig. 1. The tire was described to me as a recap, which had flown off a mounting machine at about 25 lb. internal pressure, causing personal injury. Hand manipulation showed the bead to be fractured at a location bracketed by the chalk marks in Fig. 1. I was asked to investigate the fracture and in particular to determine whether or not it occurred during the mounting process.

Figure 1: Subject tire, as received.

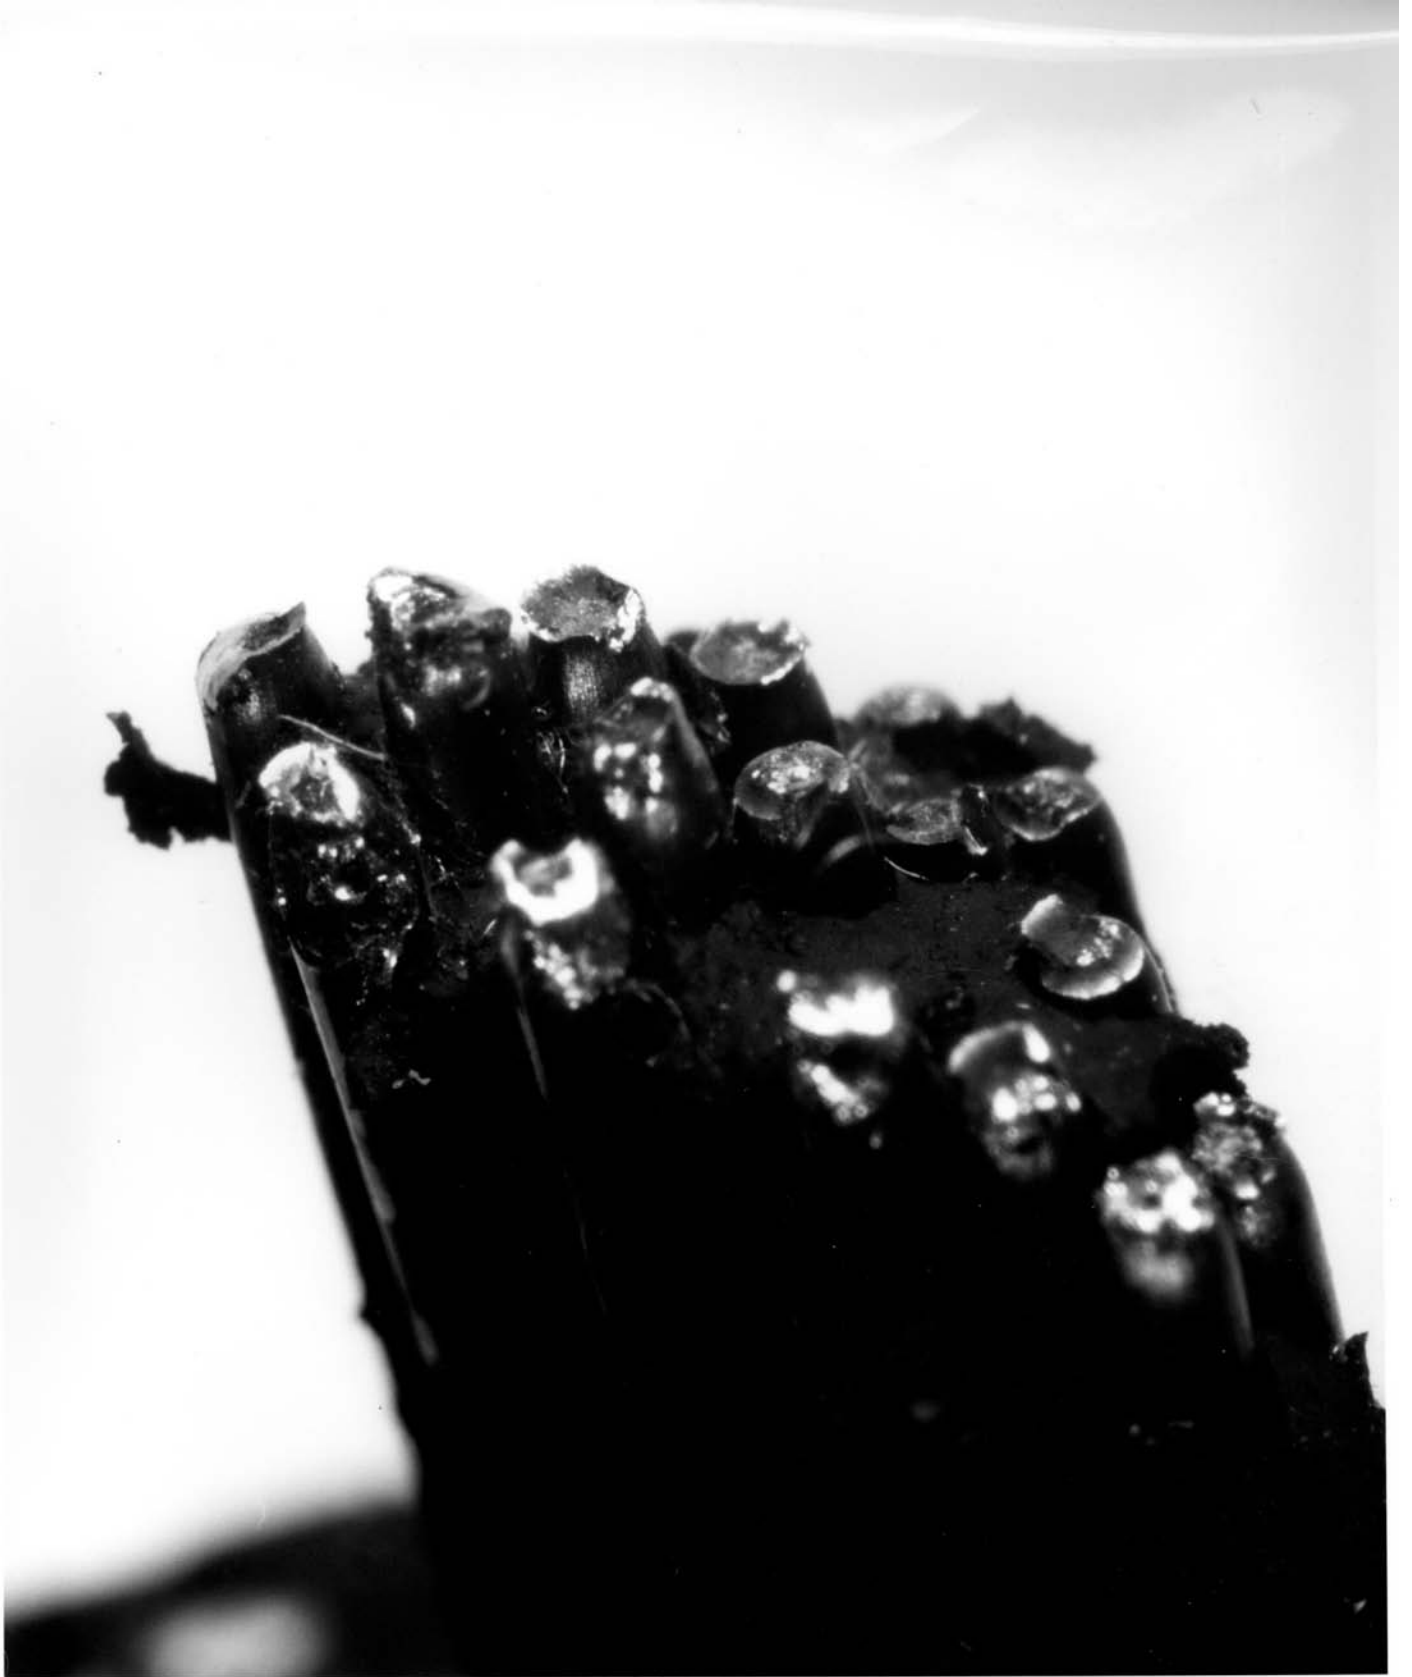
Figures 2, 3 and 4 are photographs of the ends of the fractured bead wires. All the wires are seen to have broken in the ductile "cup-cone" made characteristic of sound, ductile material. This type of fracture comes from a stress being applied along the axis of the wire. Failure due to fatigue, or to bending the bead or striking it from the side, could not give this type of fracture.

Thus, the bead is of an appropriate material, which fractured in a ductile manner due to the application of a stress along the wire axis. The most probable means by which such a stress is applied is over inflation. Inflation would have to be far above the 25-30 psi operating level to fracture the cord. A pressure the order of 100 psi would be a reasonable estimate of the required inflation.

Figure 2: View of bead wires, showing ductile fracture.

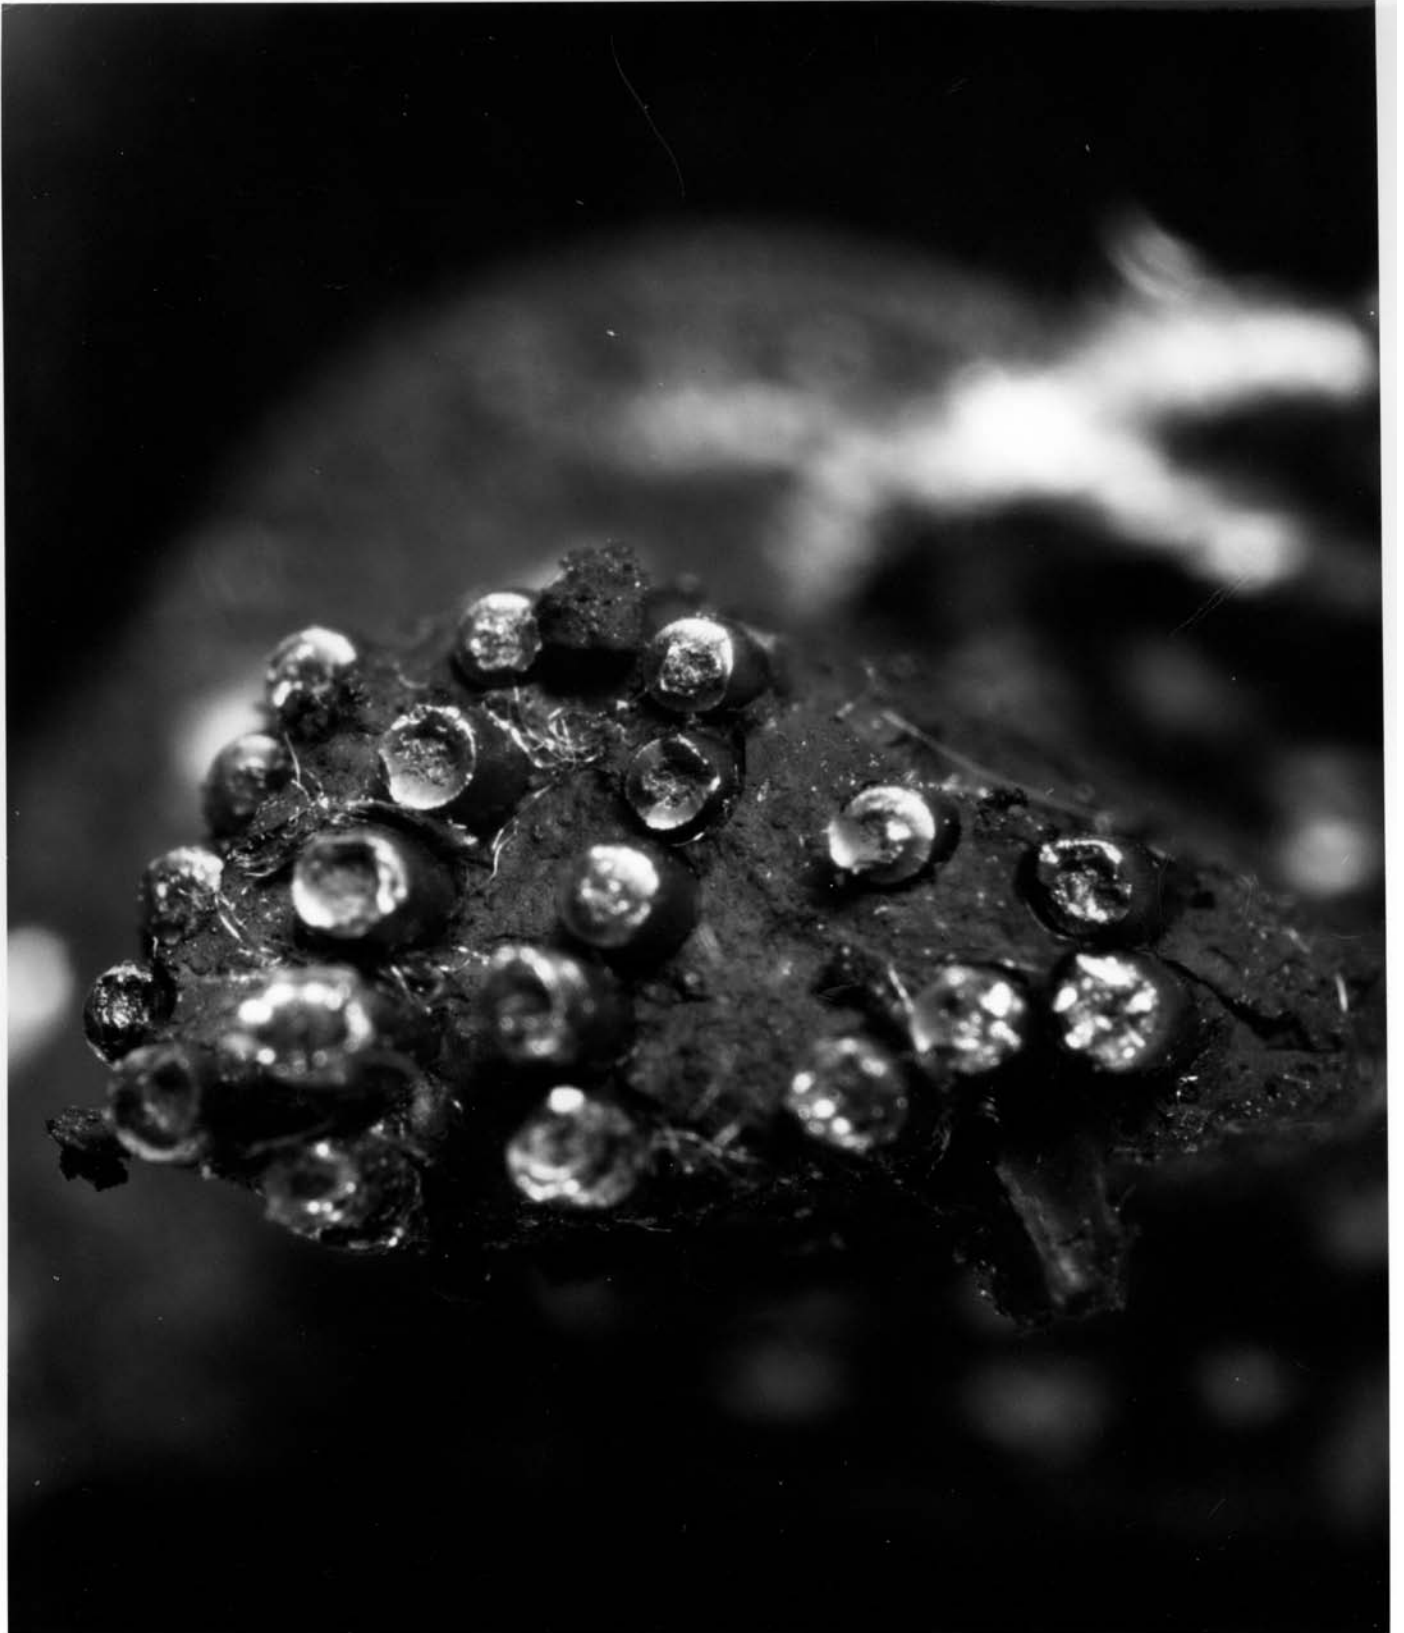
Figure 3: Another view of bead wires, showing ductile fracture.

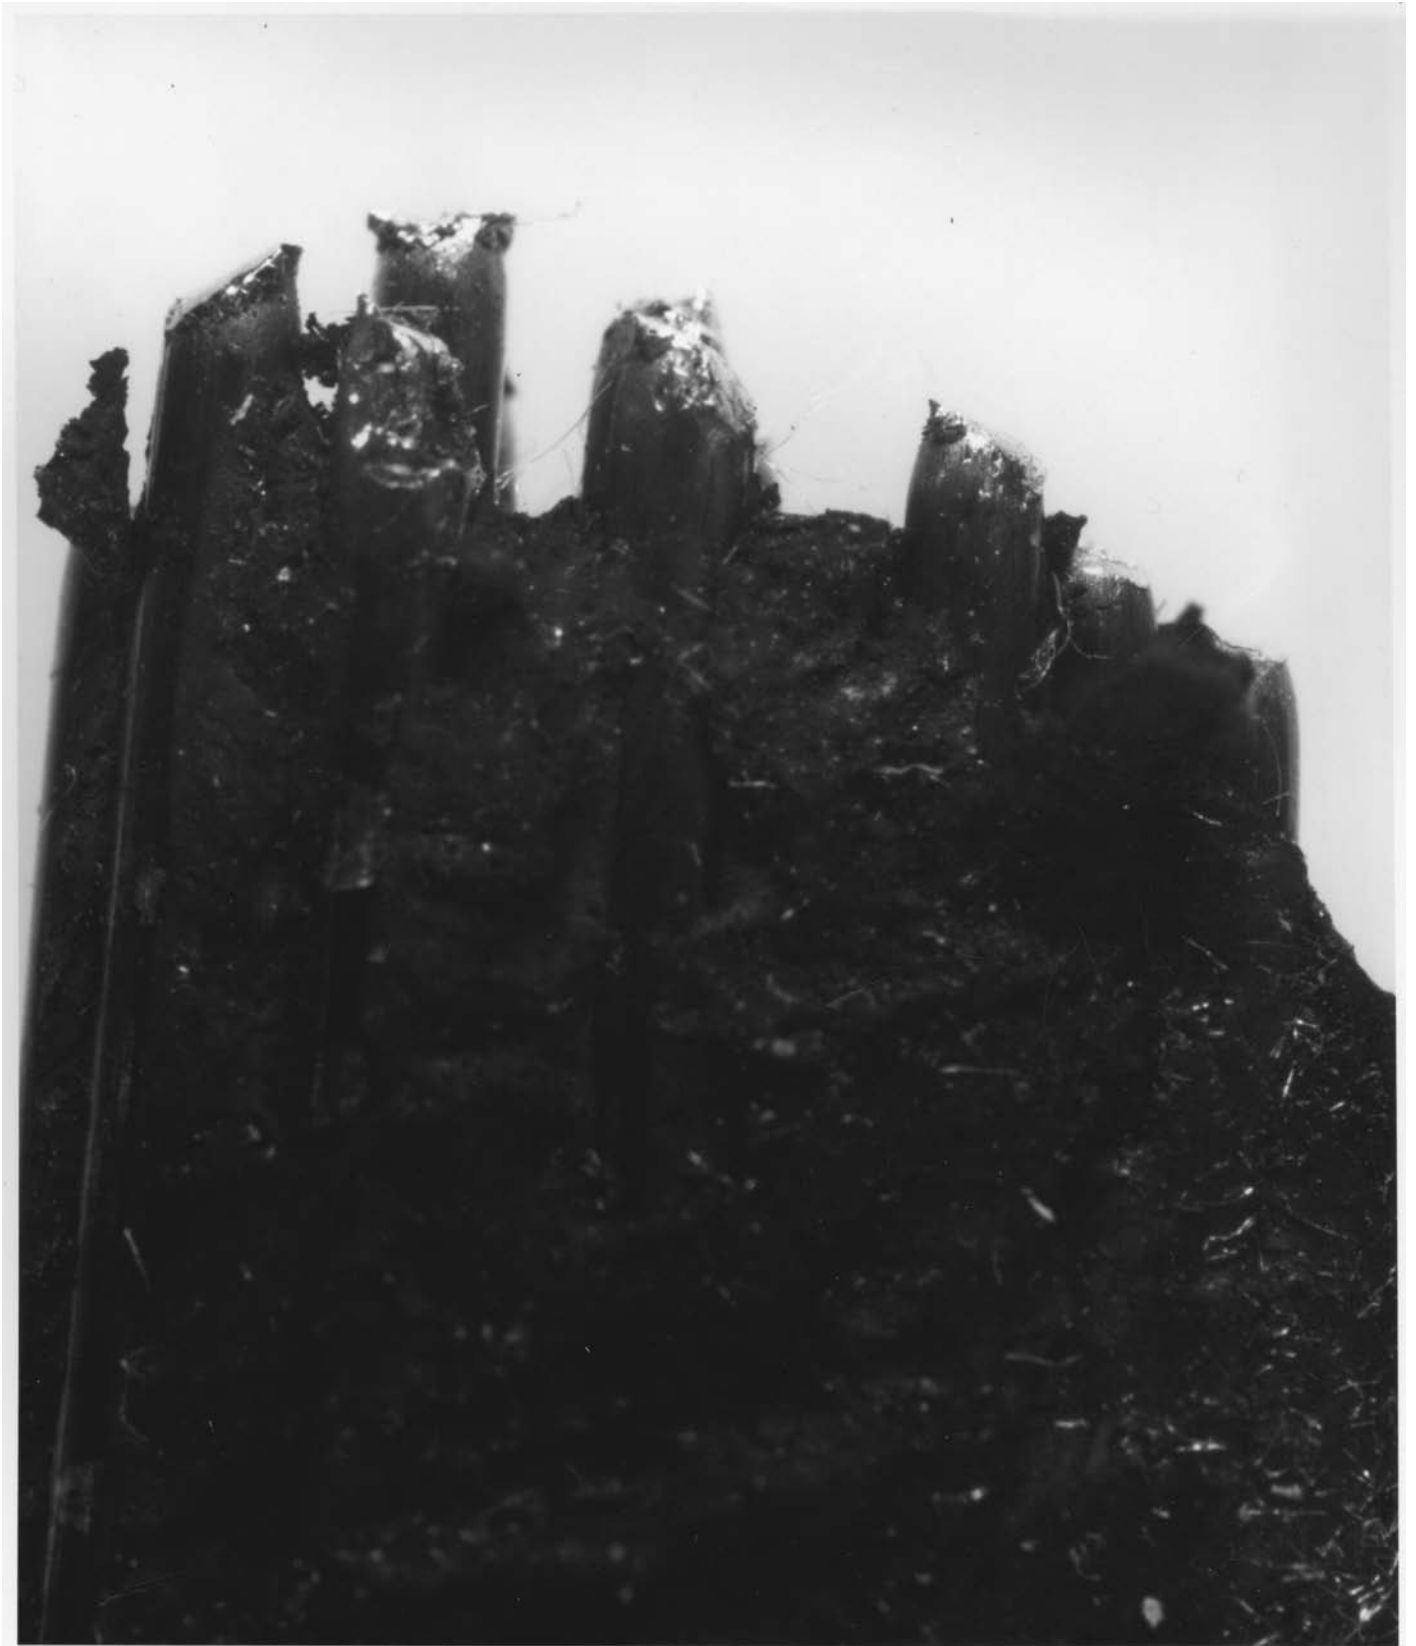
Figure 4: Side view of bead wires, showing ductile fracture.

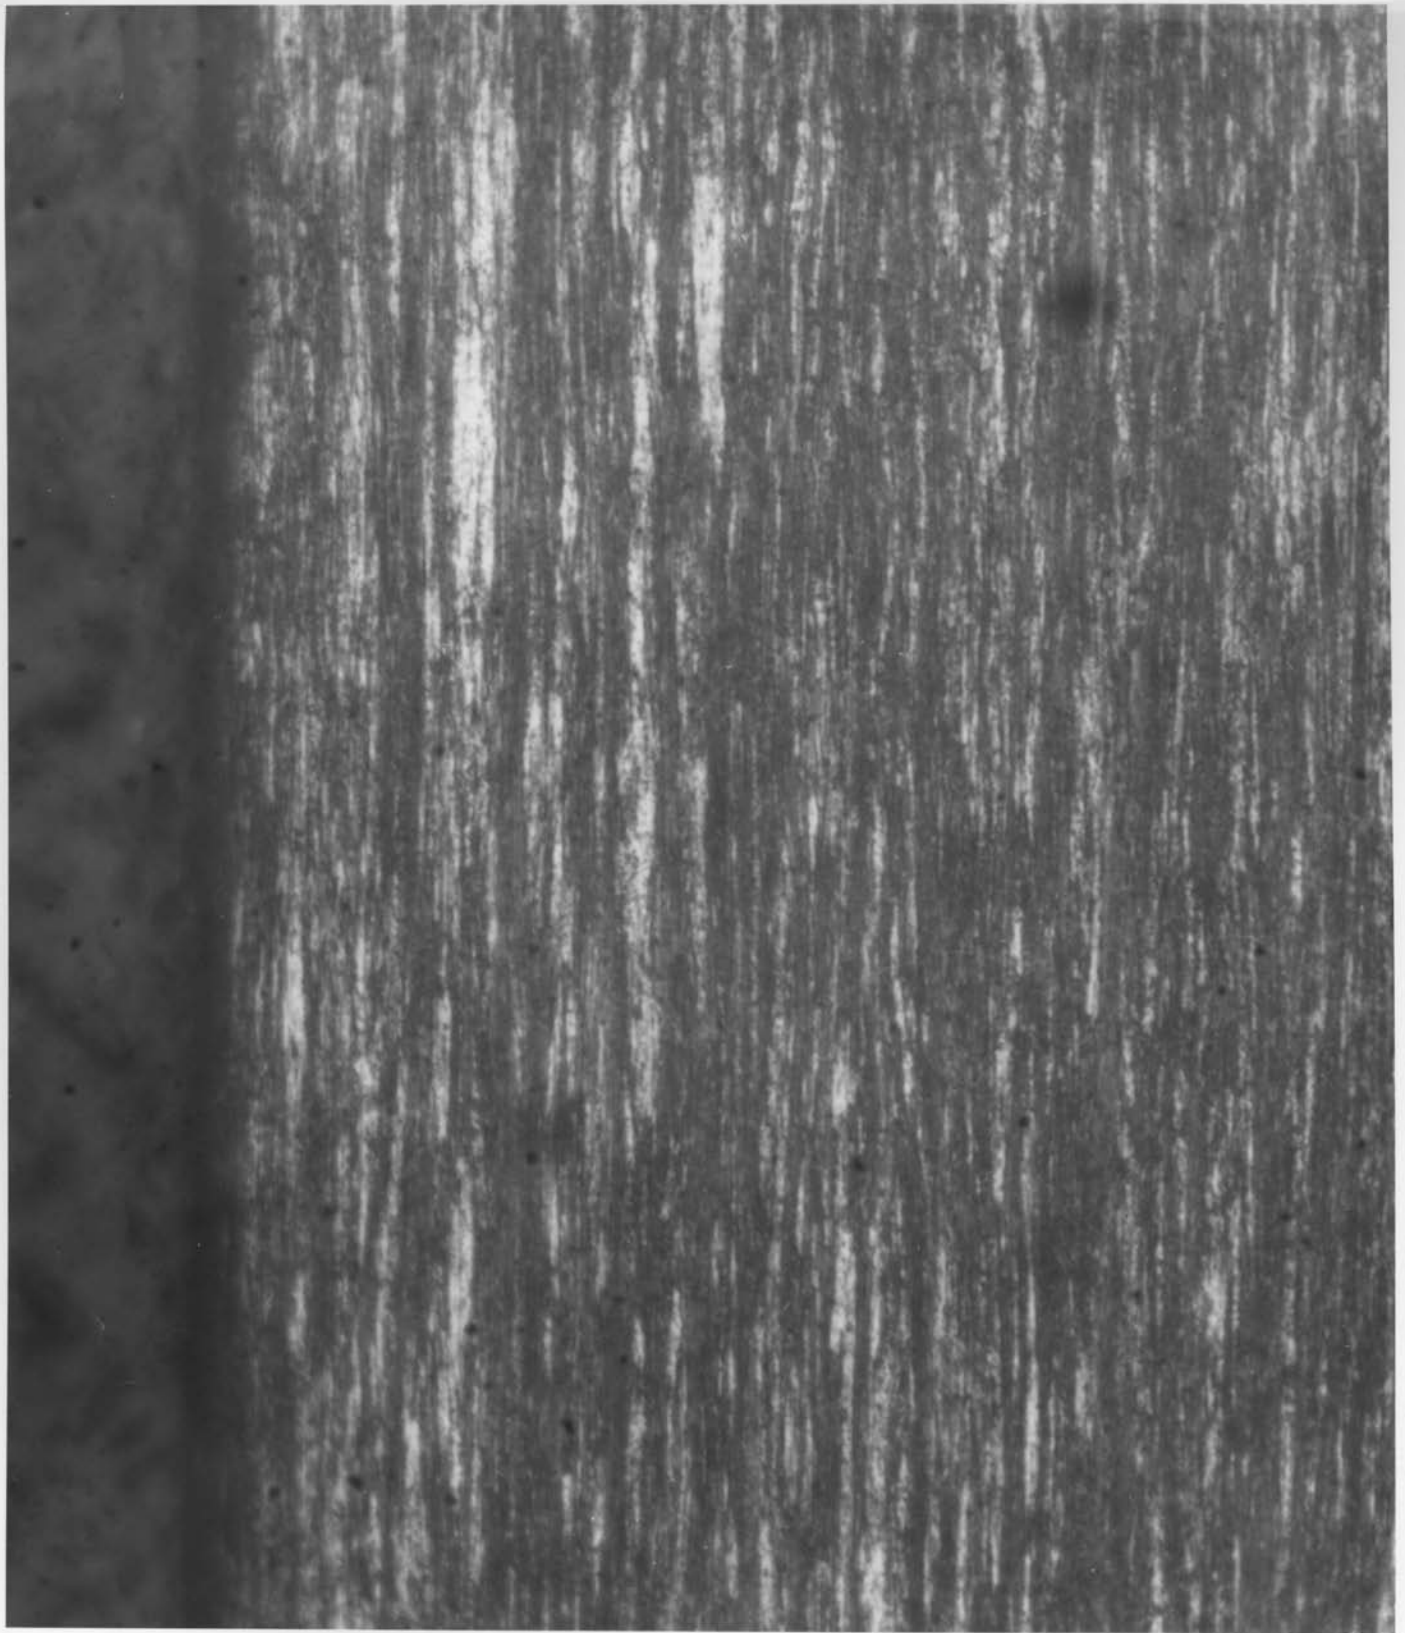
Figure 5 is a photomicrograph of the internal structure of the bead wire. The material is a heavily drawn pearlitic steel, which is an appropriate material for the bead.

Figure 5: Longitudinal section of fractured bead wire, showing the cold-drawn internal structure. (400X)
